DRILLING REPORT FOR KIROBA-MALULU BOREHOLE IN KAMULI

Prepared by: Ayebale Ared

December, 2019

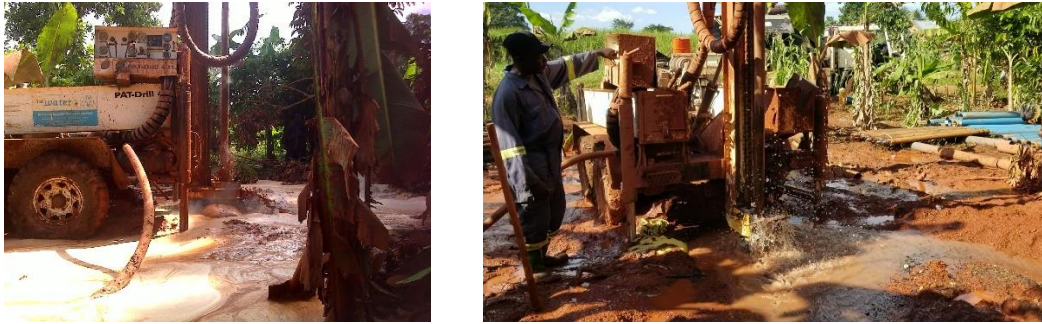
Figure 4: Drilling activities

From one attempt, the borehole was achieved at 30.90m.

This borehole after installation of permanent casings, was gravel packed and developed until water cleared and airlift yield was estimated after well development as 7,200 l/hr.

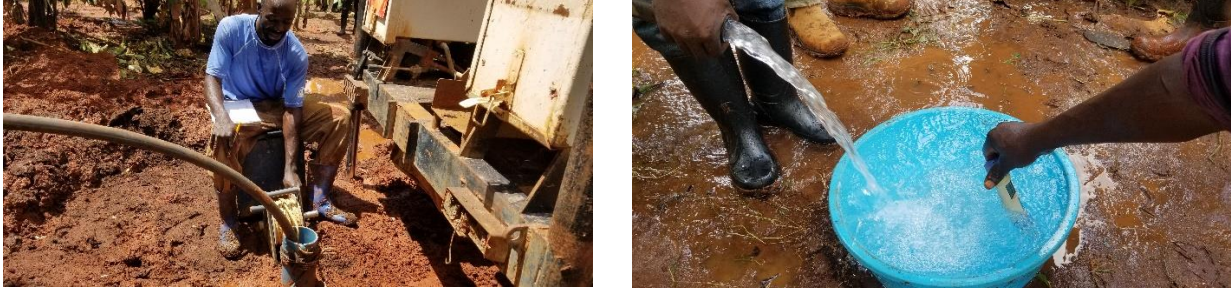
Figure 5: A technician taking results and measuring E.C during test pumping

Test pumping activities were carried out on 1/12/2019. This borehole was subjected to a short constant pumping rate of three (3) hours and recovery until a recovery of 99%, and at the end of test-pumping, a water sample was collected and taken to Lira regional laboratory for Physio-chemical quality analysis.

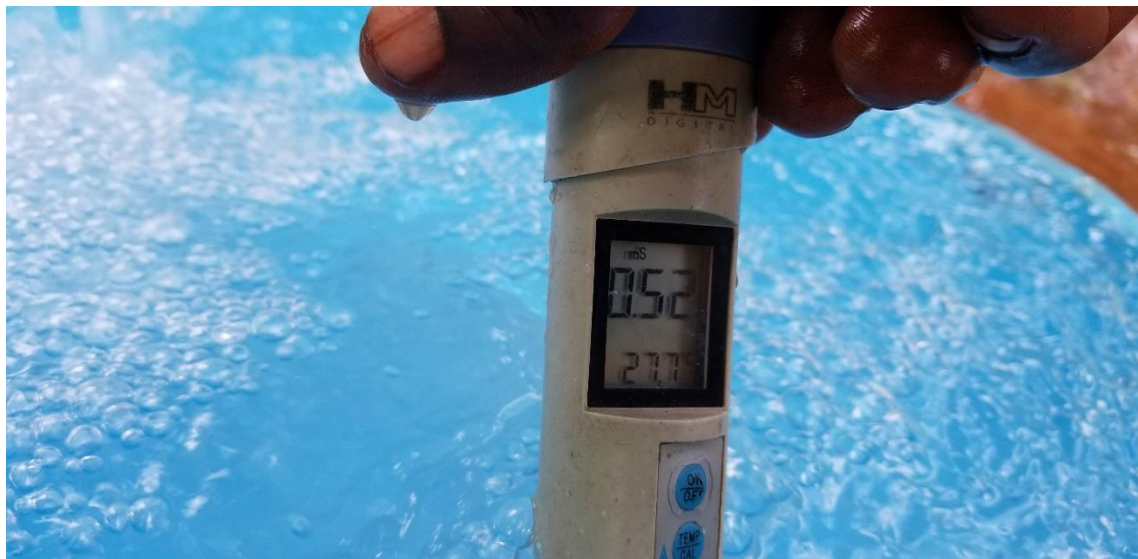
Figure 6: E.C measurement during test pumping

The results of the water quality analysis from regional laboratory Lira indicate that the water quality meets the standard for human and livestock consumption. The water quality analysis results are detailed in Annex 3. However, it's a good practice to measure the ambient (i.e. E.C and pH) conditions of ground water right at the time of test pumping as water is drawn from the borehole, the contractor only had an E.C meter and was found in acceptable ranges of (520/2500) μ S.

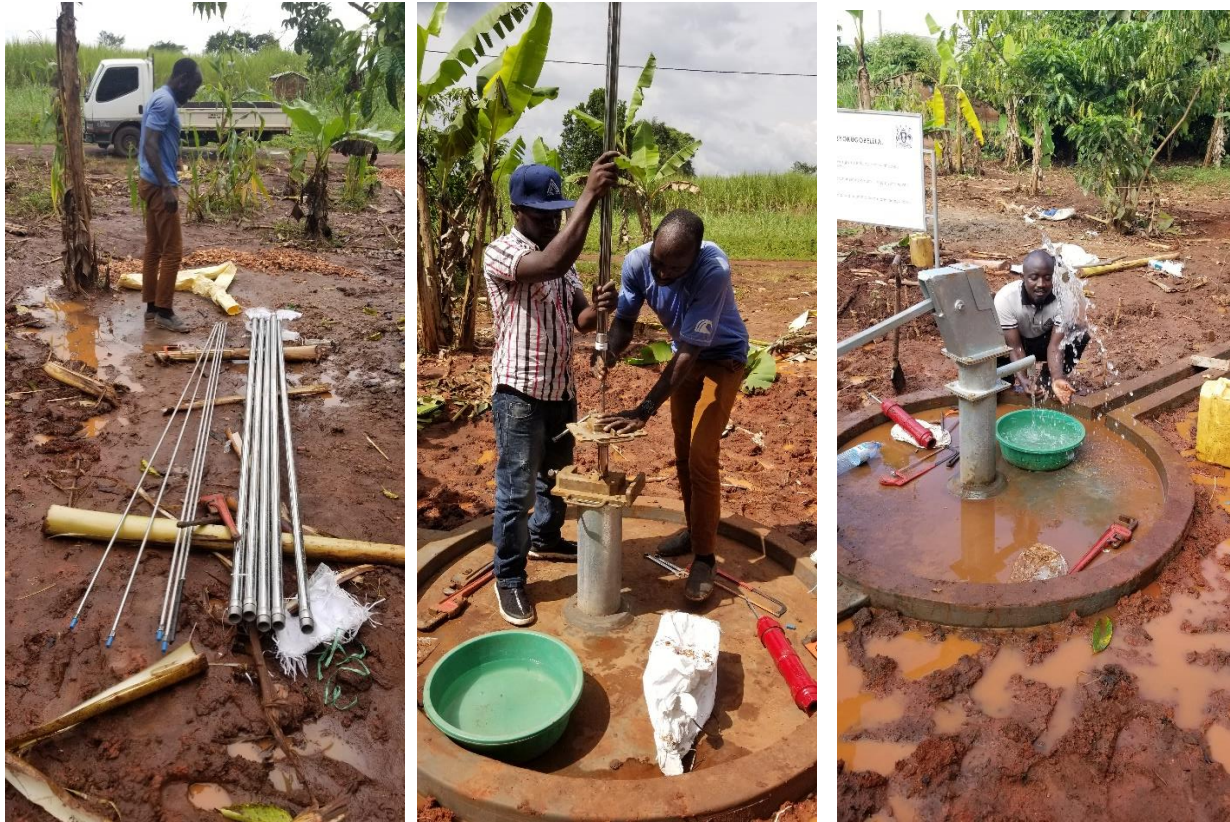
Figure 7: Hand pump installation activities

Stainless steel hand pump parts were installed on 7.12.2019. It took 7 strokes to bring out the first drop of water and after 20 minutes, a leak test was done, and water began coming out at half a stroke indicating the installation was well done. Installation certificate is shown in Annex 2

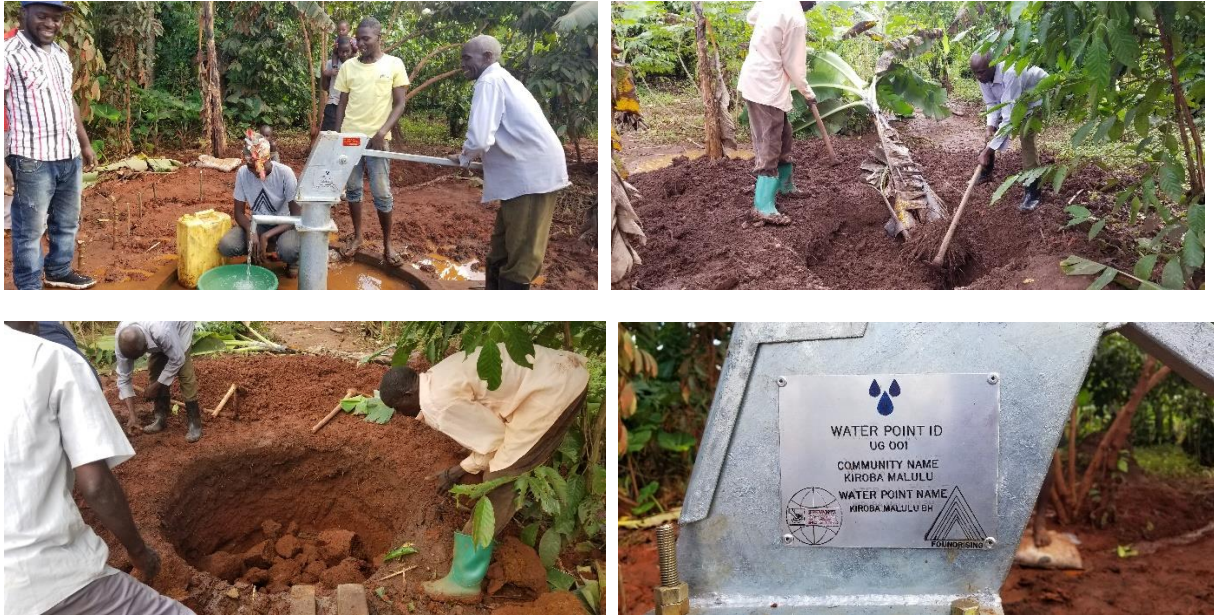
Figure 8: a community member pumping after installation and guiding the community on soak away pit

The community was guided on soak construction where members who were shown the dimension and they dug it one meter deep, was not fully filled with lateritic stones since the community had lost a member and most people to help bring stones were at the burial.

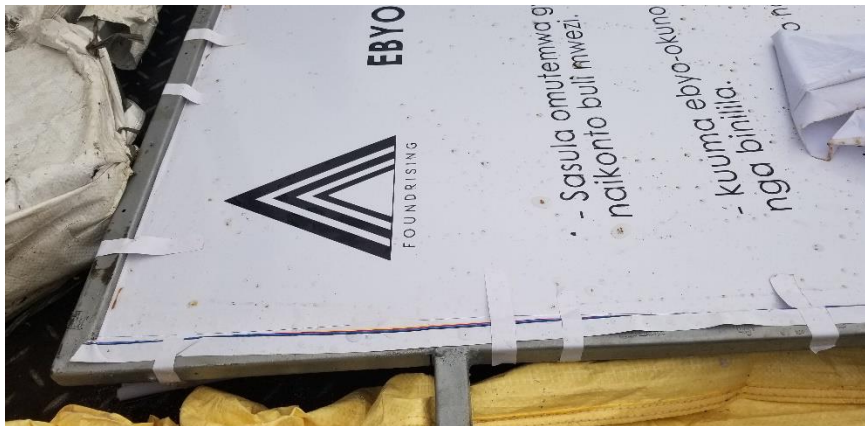
Figure 9: Sign post made with a sticker polyethene.

- A small rig is not a good option for the organisation to own since it increases costs of being in field against time and has difficulties in drilling competent rocks.
- Drilling in Busoga sub region is better in a dry season as accessibility can be a huge deal.
- There is always a need to measure the ambient conditions of ground water at the site especially for pH and Electrical Conductivity (E.C) during drilling and test pumping to save the fresh water aquifers from being contaminated by salty aquifers.
- There is always a need to use well experienced technicians when it comes to ground parts installation in any borehole.
- Sign post and the plaque card were of poor quality and the sign post can wear very fast since it's not a writing on the metal but rather on a sticker paper
