COMPLETION REPORT FOR FULL REHABILITATION THREE DEEP BOREHOLES INSTALLED WITH HAND PUMPS IN COMMUNITIES OF KAKOOGA CENTRAL, KIRIBAIRYA LANDING SITE AND NSOKO ALL IN BUYENDE SUBCOUNTY, BUYENDE DISTRICT.

The project was contracted to Reddys borehole and technical services Ltd.

INTRODUCTIONS

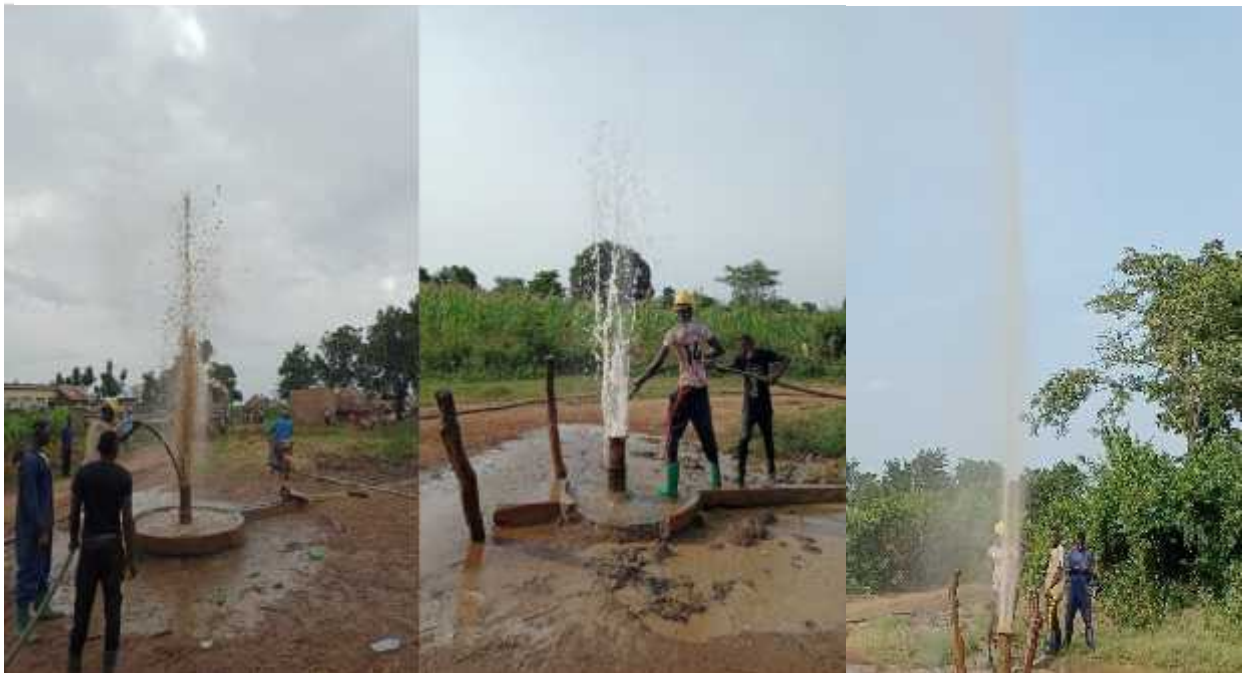
Photo showing borehole flushing in Nsonko, Kakooge and Kiribairya Villages in Buyende District

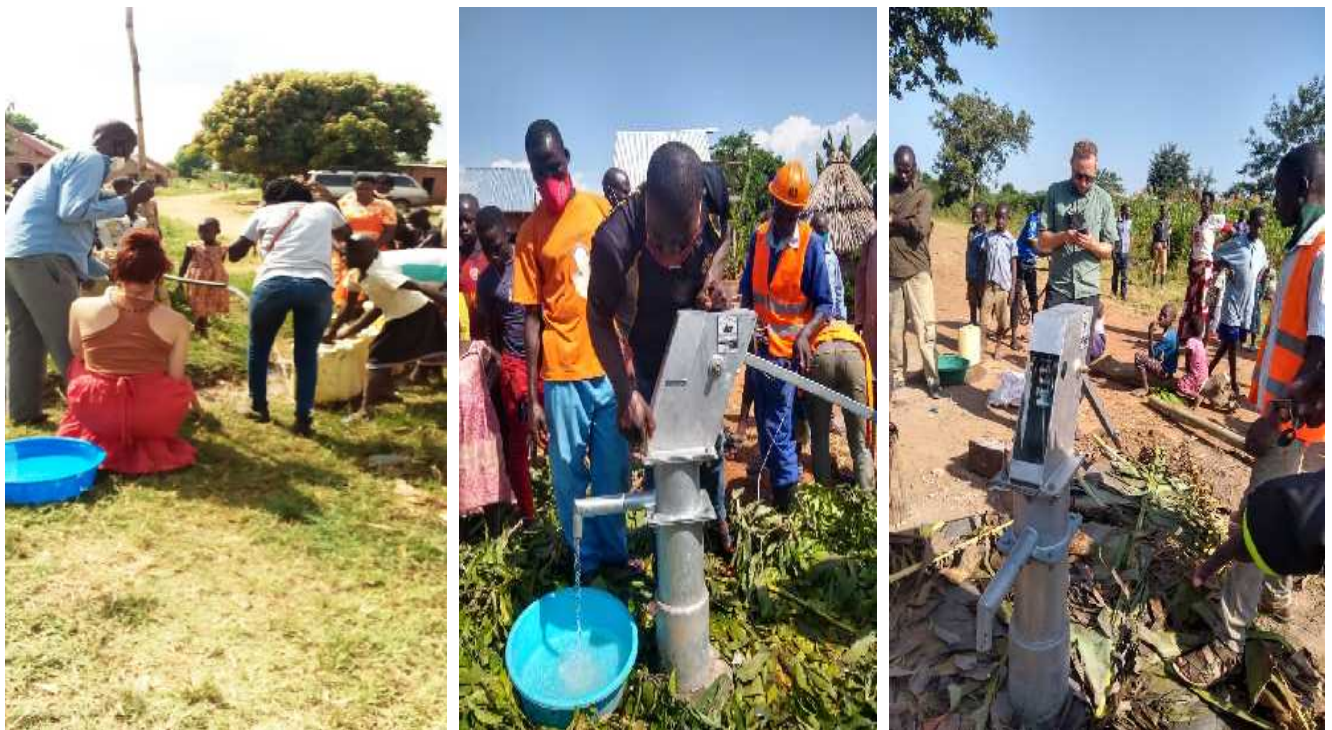
The above photos shows borehole pump testing and borehole installation in Buyende District.

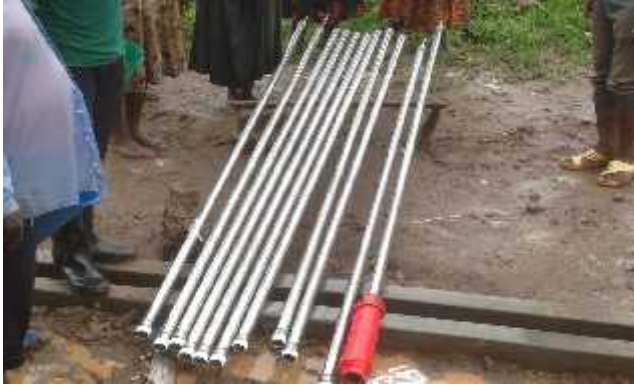
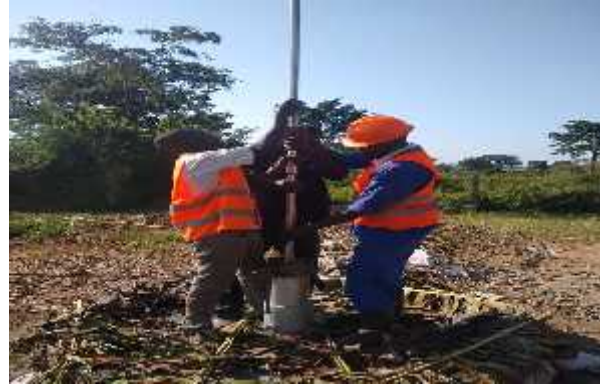
The above photo showing stainless steel pipes and also during Installation in Buyende District

Of all the three (03) boreholes, all were installed with stainless steel pipes and rods, all the three (03) boreholes were installed successfully and the community people are already using it. They are also advised to be very careful in handling the borehole so that serves them for long period of time.

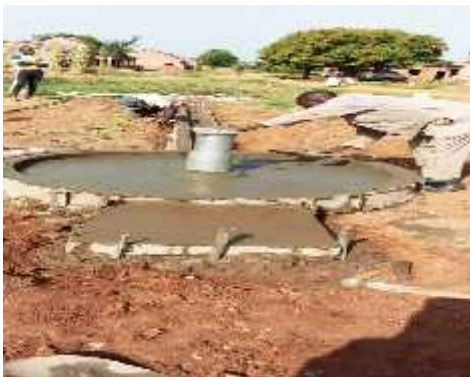
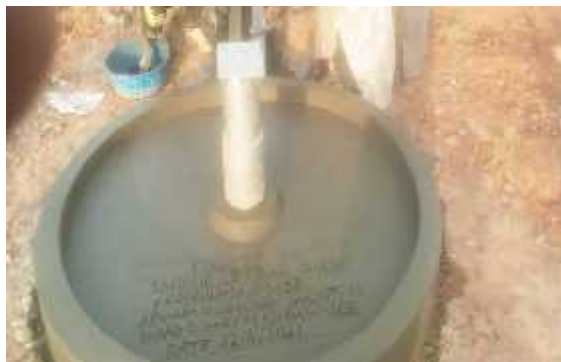
The above photos shows apron casting at Kakooge village in Buyende District.

The above photo shows the apron construction in Kakooge

The construction of the concrete slab and placement of permanent borehole top flanged cover was delayed till the completion of the yield test exercise. This was to avoid breaking of the concrete slab by the Rig if the yield test had to be done after the emplacement of the slab. Each borehole was provided with a thick and reinforced concrete slab measuring 2.8 × 3.0m. The concrete slabs are about 800mm above ground level. Also on the well heads are welded steel flanges base and cover which are secured by bolts and nuts.

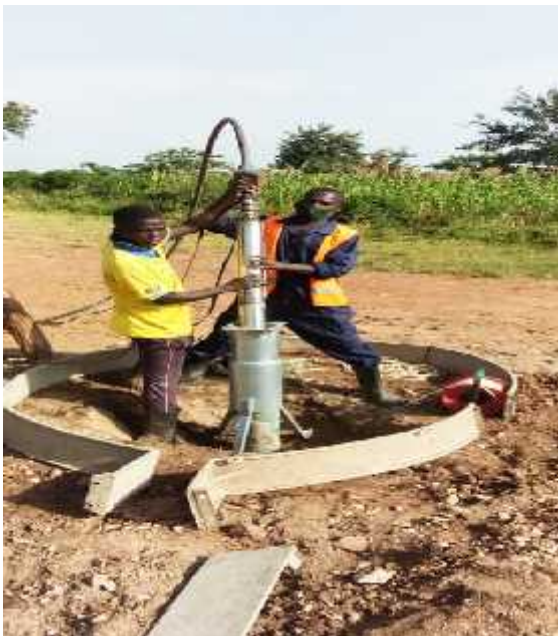
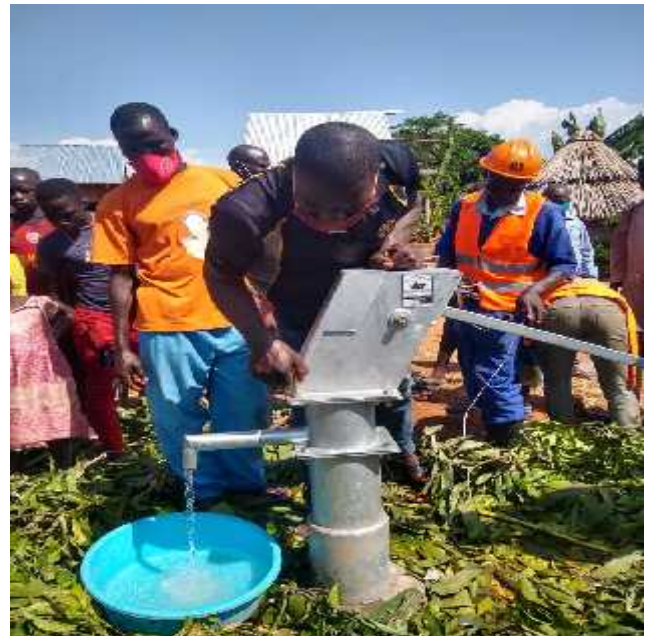
The above photos shows the apron casting, pump testing and a completed borehole.

The well head and the pedestal were painted with aluminium and later two coats of non-toxic water-colour paint were applied to the well head work. The hand pumps were secured with padlocks and the keys given to the water works staff.

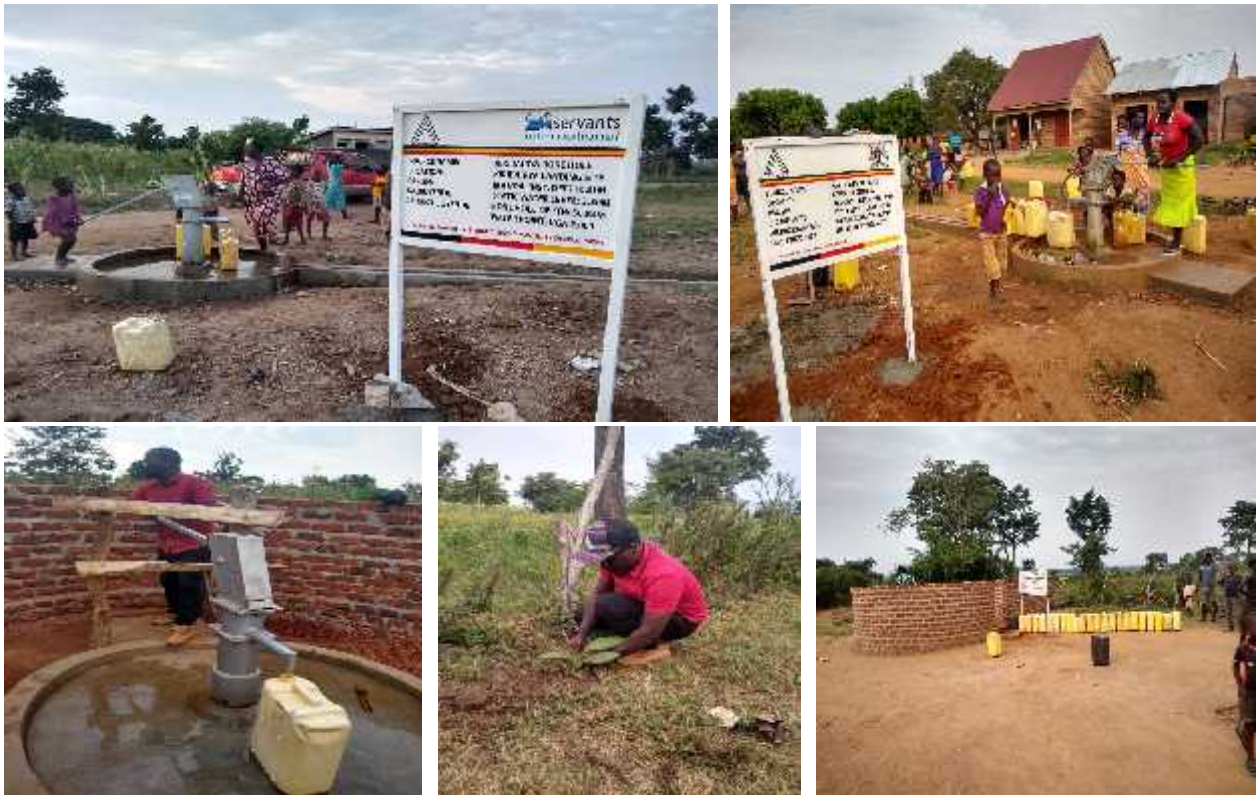
The above photos showing some of the completed boreholes for Foundrising Community Development in Buyende

Existing boreholes were developed by removing pump and the riser pipes, airlifting of the wells until water is clean and sand free and changing of all necessary components and restoring of the boreholes to functional condition.
