PROJECT TYPE: DEEP WELL COMPLETE REHABILITATION

COMPLETE DEEP BOREHOLE REHABILITATION 8.023 LUMULI C (AKUTALA BH)

ORGANIZATION: FOUNDRISING COMMUNITY DEVELOPMENT

REPORT DATE: May 15, 2024

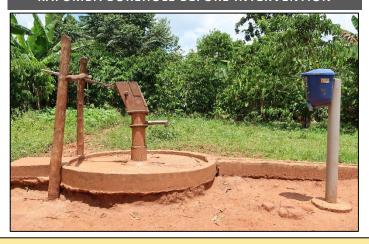
Akutala borehole is in Lumuli c, a village in Jinja District . The population using this source is less privileged with all households surviving on substance farming and the deep well being the major source of drinking water available to the people. However, the deep well has been malfunctioning because the installed pipes had cracked & the deep well had silted with mica.

KAFUMBA BOREHOLE BEFORE INTERVENTION

A deep well rehab is subjected to a three-hour blowout of the water. After blowing out this borehole the silting and mica production was resolved. The mica testing demonstrated that it was reduced by 95% after our rehabilitation. This water source has been returned to a safe and healthy source for the community and has been verified by the Ministry of Water. The source has also been installed with U2 stainless pipes with a serving longevity of 15 years saving the community, your contribution has made this possible, thank you for your support. A permanent fence has been provided to prevent animals from contaminating the area.

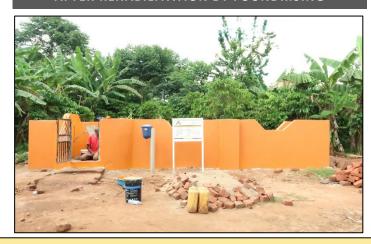
AFTER REHABILITATION BY FOUNDRISING
