# **BOREHOLE REHABILITATION REPORT**

## ***2022 - JINJA CITY (UGA-3)***

**Prepared by: Welukwagana David**  
**Field Engineer**

**May 2022**

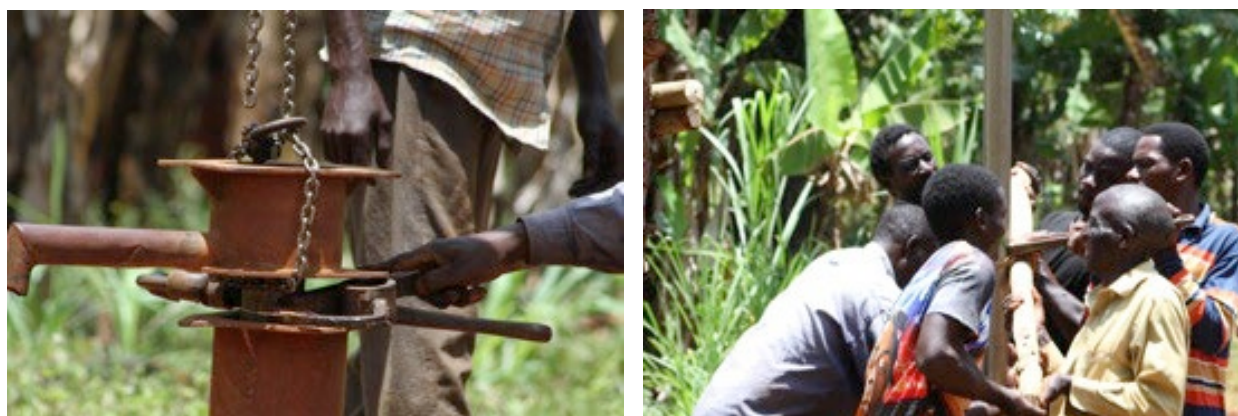
Figure 1: Showing Fishing of Akisofeli borehole

- Unsafe open hole of Akisofeli borehole which led to pipes and cylinder getting stuck which called for fishing, this was another extra cost to Foundrising because it was not included in the previous contractor's quotation.
- Poor road network to the sites because work was done during rainy season.

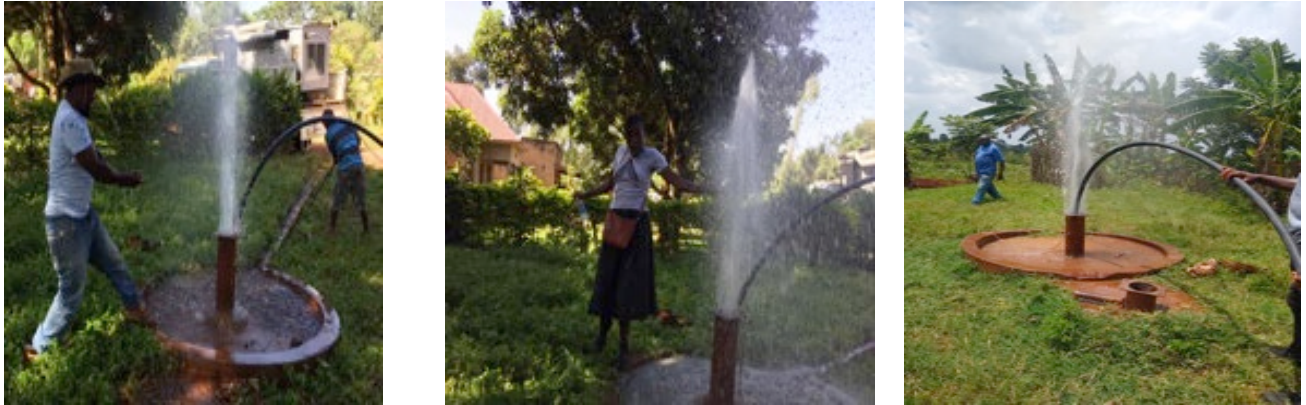
Figure 2: Blowing of Akisofeli, Lwalanda and Musenze boreholes

The boreholes were blown to desilt and confirm current depth and confirm their quantity of water (yield) and the physical quality parameters like colour. All these were found in acceptable range of the yield required by the ministry of water and environment while showing clear discharge were thereafter dismantled. It should however be noted that the borehole of Akisofeli had its pipes and cylinder stuck inside and it required fishing. It was successfully fished and results shows this borehole had an unsafe open hole at 25.8M and this was the cause of the problem of pipes getting stuck because the boulders inside the borehole could hold the cylinder and pipes inside. And also the borehole of Lwalanda did not fully clear during blowing but when it was left to settle, it gave clear water during the constant three-hour test pumping.

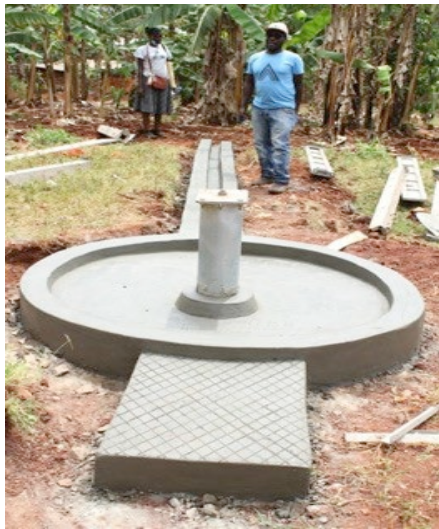
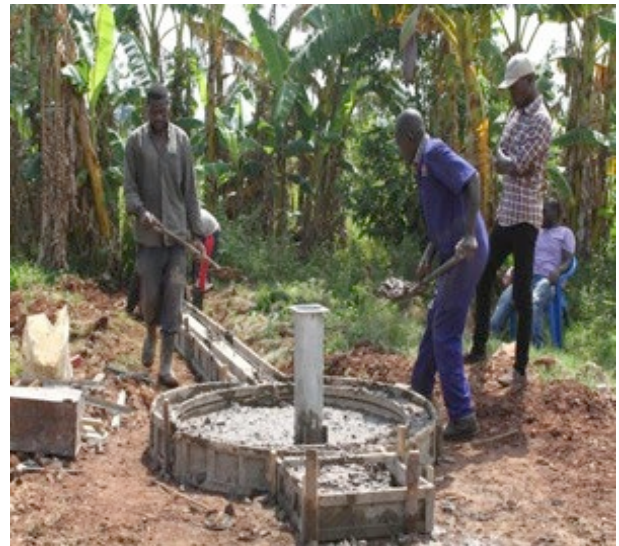
Figure 3: Showing Akisofeli borehole before and after rehabilitation

These boreholes were not operational for some time and community members were eager to have safe and clean water again, the team could not wait for water quality results to cast because the results take some weeks to be out. Therefore, they were casted and later installed but not connected to wait for the curing process of the apron, hand pumps were installed with stainless as guided by ministry of water and environment.

Details of installation depth and materials are shown in Table 6 below. After installation FoundRising Community Development took an initiative to fence the borehole against animals and any other vandalism using brick fence and soak pit was dug to ensure wastewater management.

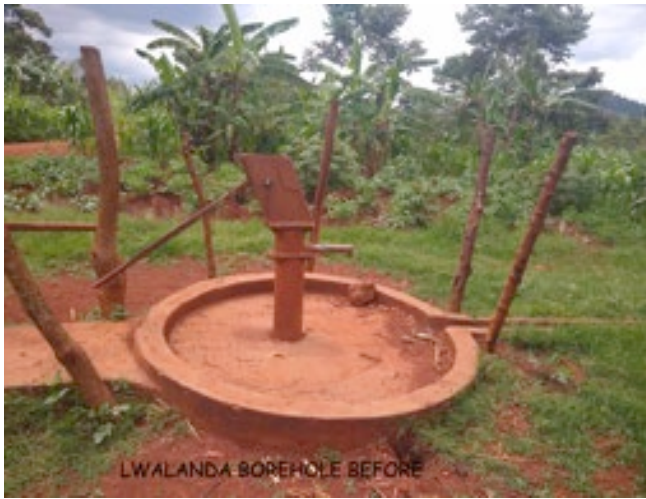
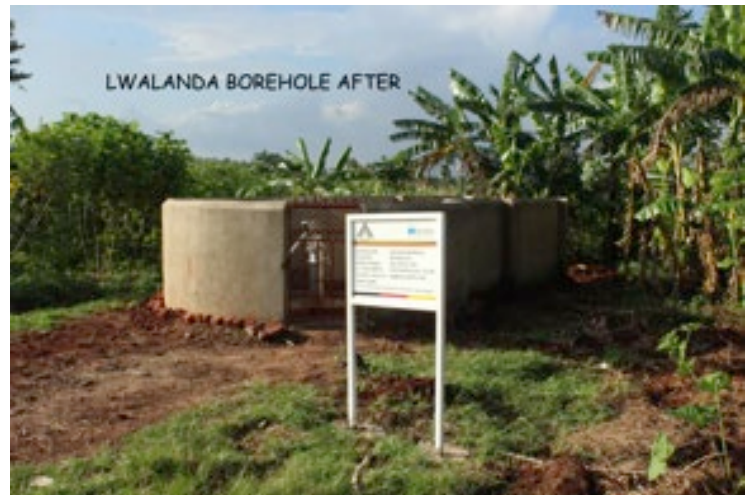
Figure 4: Showing Lwalanda borehole before and after rehabilitation
