14. IKOONA

IKOONA, BUYENDE, UGANDA
NAMUSITA, BUYENDE

BOREHOLE NUMBER: UGA.5.014

PROJECT TYPE: DEEP WELL REHABILITATION

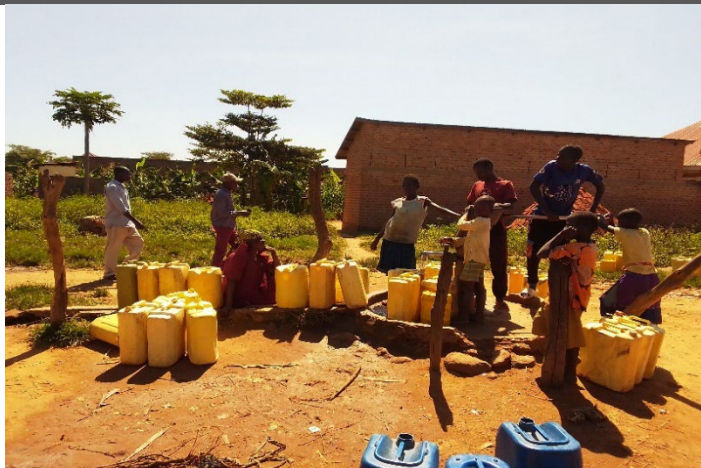
BEFORE

Ikoona borehole, was drilled in the 1970s by the government of Uganda and has served the community for 52 years. During the past 4 years, the functionality of the borehole reduced due to blockage in the aquifer due to silting and cracked pipes. The pipes at this borehole are old stainless steel (U3 type) and can longer be replaced, additionally repairing them is quite difficult due to the weight of each pipe.

We have fully rehabilitated Ikoona borehole, and we expect this borehole to benefit the community for at least the next 16 years. The activities involved blowing which unblocked the aquifers which had been blocked by stones & mud after many years of service.

We also reinstalled this borehole with U2 stainless pipes, recommended by the government. These pipes will be easier when it comes to repairs and easily accessible on the market. The source was also provided with a permanent fence which prevents animals from approaching the water source.
