10. LUBANI

LUBANI C VILLAGE, JINJA, UGANDA
NAMAGERA TOWN COUNCIL
BOREHOLE NUMBER: UGA.4.10

PROJECT TYPE: DEEP WELL REHABILITATION
GPS Coordinates: 0°37'07.9"N 33°07'21.2"E
Map Link: <https://google.com/maps/place/0.6188574,33.1225498>
Est. Population that uses this Borehole: 1,524 people
Est. Depth of Borehole (meters/feet): 40. 27 m /132. 12 ft.

PROJECT SUMMARY

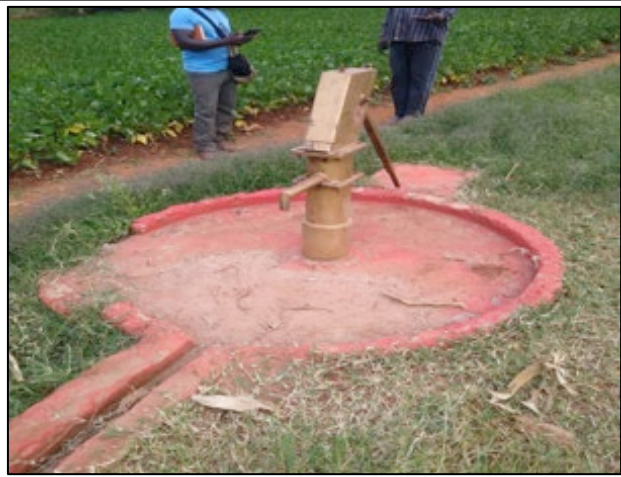
BEFORE

Lubani central borehole, was drilled in 2005 by the government of Uganda and to date it has served the community for 18 years. During the past five years, its functionality reduced due to faults in pipes and had even started silting which had negatively impacted the community members.

With your support, we have been able to fully rehabilitate this water source and we expect this water source to benefit the community for the next 15 years!! The water quality was tested by the Water Ministry and is has been verified safe for human consumption. The borehole yield is sufficient for the community at 3,060 liters per hour.
