# 11. KIVUBUKA B

KIVUBUKA B CELL, JINJA, UGANDA  
JINJA NORTHERN DIVISION, BUDONDO

BOREHOLE NUMBER: UGA.4.011

**PROJECT TYPE:** DEEP WELL REHABILITATION

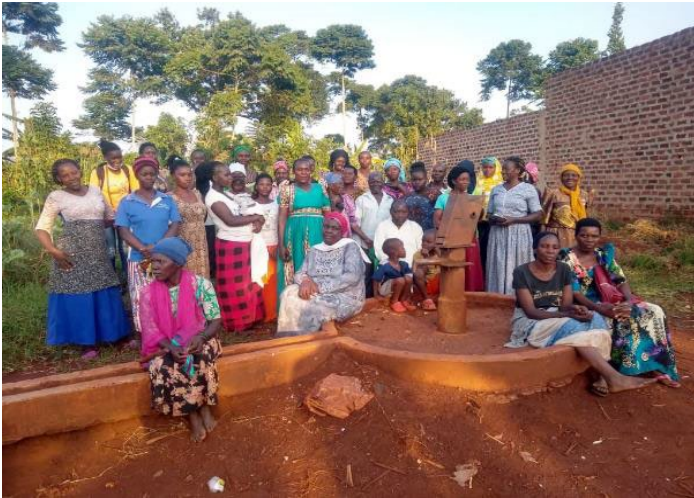
## BEFORE

Byakika borehole was drilled in 1995 and it has served the communities of Invunamba, Kivubuka & Bujagali for 27 years. Over all these years, the borehole had never been serviced fully, which has reduced its yield and functionality.

FoundRising successfully managed to complete rehabilitation of this water source. During the restoration we discovered that there was a blockage in the prior flow and after our reconstruction this water source is now yielding 6,120 liters per hour – which is enough to now supply three communities! The quality of the water was also tested by the Water Ministry and has been verified for human consumption.
